Watershed degradation and the growing risk of erosion in Hawassa-Zuria District, Southern Ethiopia

Zenebe Mekonnen Gebretsadik

DOI: 10.1111/jfr3.12033

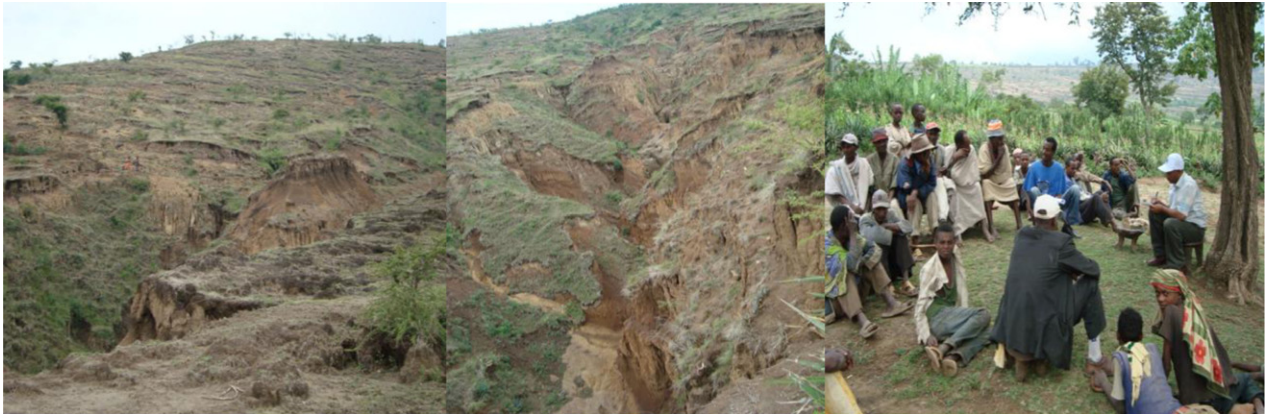
Plate 1 Parcel of a degraded subwatershed (left), gully formation (centre) and discussion on how to solve it (right) (photo, Zenebe M. 2009).

It was recognised during the transect walks' field observations that the subwatershed is almost become bare and degraded (Plate 1). However, there is some recovery at the top of the subwatershed due to some intervention by planting *Acacia saligna* by Meserete Christos (local NGO) and control of animals from entering to the site. When farmers were asked what they feel when they see the land degraded that way, and what were the possible causes; they responded, 'we are very discouraged by the loss of trees and soil from the landscapes which was dense woodland before. The cause was ourselves in that we had removed the entire tree and converted the land for agriculture. The consequences has brought the current sever [sic] conditions which even threaten our lives'. The farmers said that 'in *Sidamgna Umbulo* means dense forest and *Wacho* means acacia, that is, *Umbulo Wacho* means dense acacia forest'. They have expressed their willingness to cooperate and participate in a programme which enables them to recover their degraded landscapes.

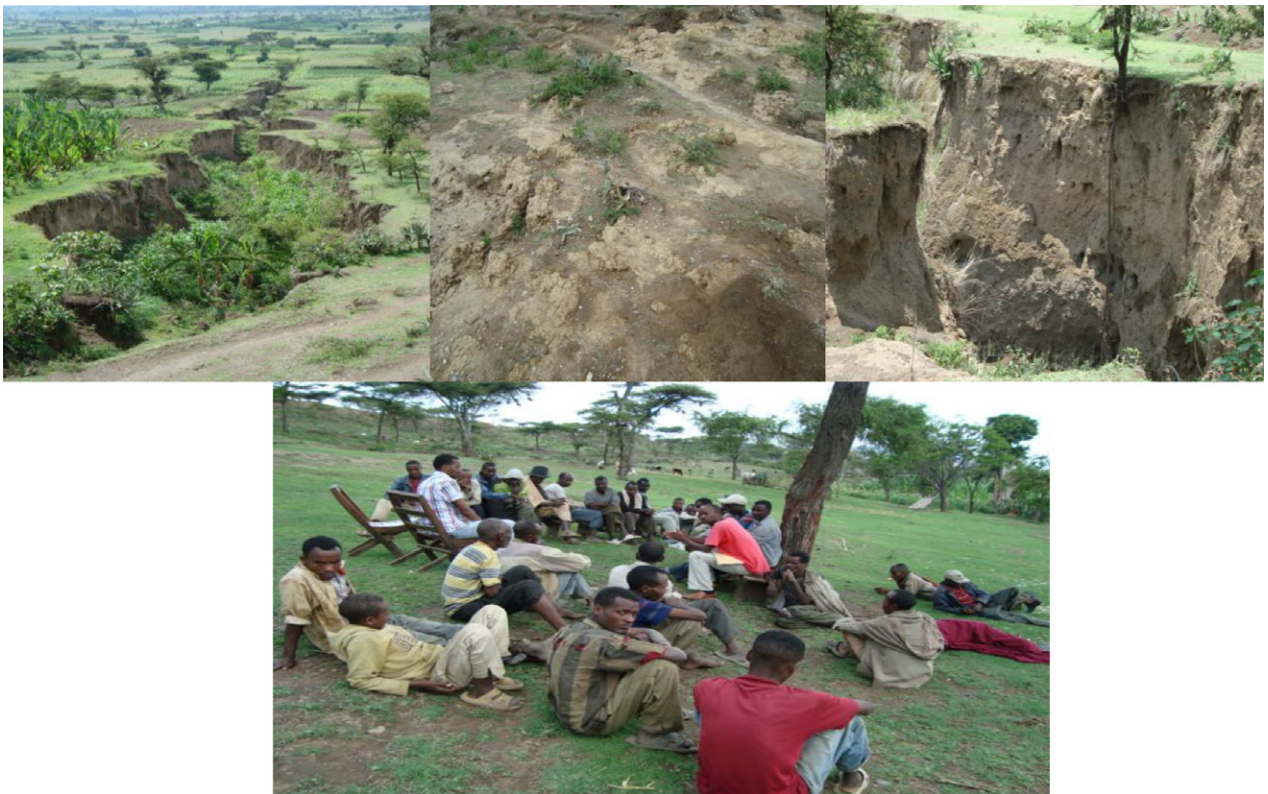
Plate 2 Part of selected subwatershed (top centre) and the two gullies at its outlet (top left and right) and discussion with farmers (bottom) (photo, Zenebe M. 2009).

During group discussion and observational survey, it was learnt that land degradation at hill sides is the major cause of flooding downstream and the formation of most of the gullies (Plate 2). Farmers remarked that they are willing to treat the gullies, but some of the gullies are beyond their control. Tenkaka subwatershed was proposed by farmers for soil bund construction as there was a start-up action by the Safety Net Programme, which requires maintenance and strengthening. But some consensus was not reached with regard to enclosing the area because some farmers become reluctant about the enclosure as the area is their grazing land. Other participants agreed that enclosure system is one

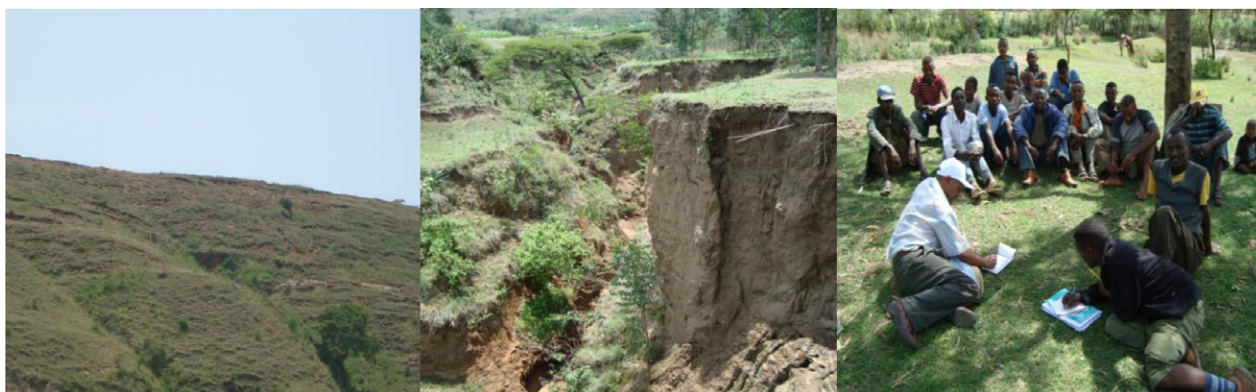
Plate 3 Subwatershed (left), a gully at its base (right) and discussion with farmers (photo, Zenebe M. 2009).

Farmers had explained that there is a need to undertake a development action in this particular subwatershed

(Plate 3). The farmers who participated in the discussion have agreed that it is the responsibility of the community to take action in order to rehabilitate the degraded watershed. They also agreed on the need to create awareness in reluctant participants on the development works for their local development and environmental conservation. Upon discussion, farmers commented that there is some improvement in the

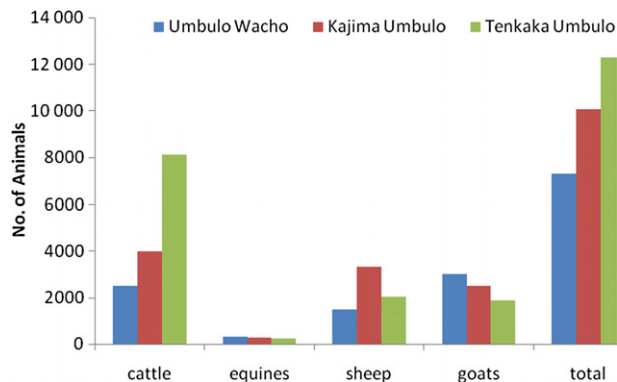
Figure 2 Animal population in Wacho, Kajima and Tenkaka subwatersheds.

The livestock population in the district in general and in the three community villages in particular is also high (Figure 2) and has resulted the overgrazing of grazing lands which leads to accelerated soil erosion and the resultant siltation of Hawassa Lake and the surrounding wetlands. This in return affects aquatic biodiversity.
